Prepared For: ABCDEF

Property Address: 123 Main Street

Inspector: WIN Home Inspection
Company: WIN Home Inspection
www.wini.com

Standard Full Home Inspection

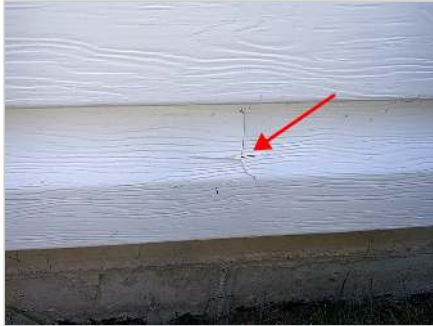
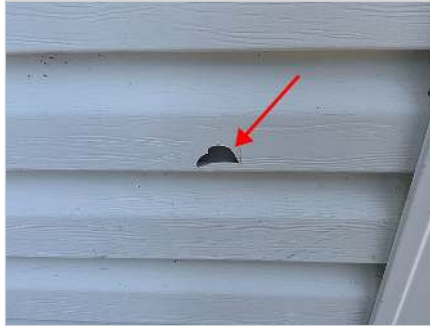
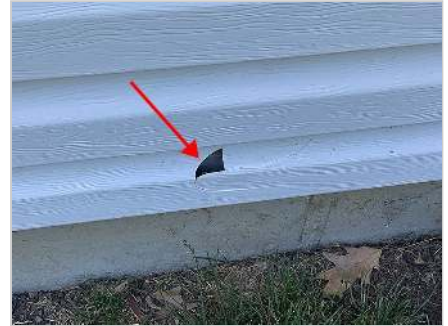
2. Exterior Structure - Siding Condition

There were sections of damaged siding in localized areas around the home. We recommend contacting a qualified handy person or siding company for repairs prior to further deterioration.

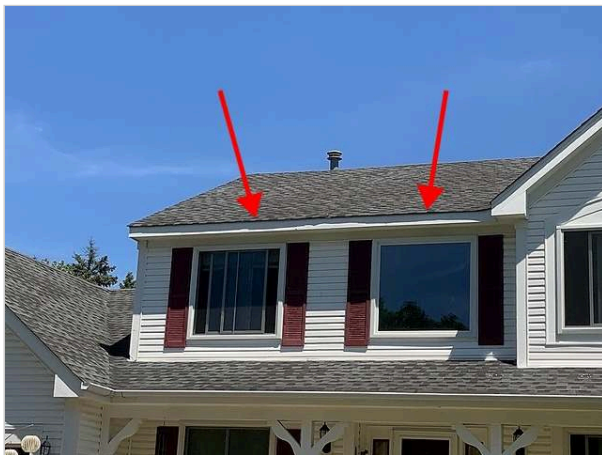
3. Roof - Gutters/Down Spouts

There was no gutter installed at the upper roof. We recommend installing a gutter in this area to help prevent premature deterioration of the roof cover below. It is recommended that a qualified gutter contractor is contacted for estimates.

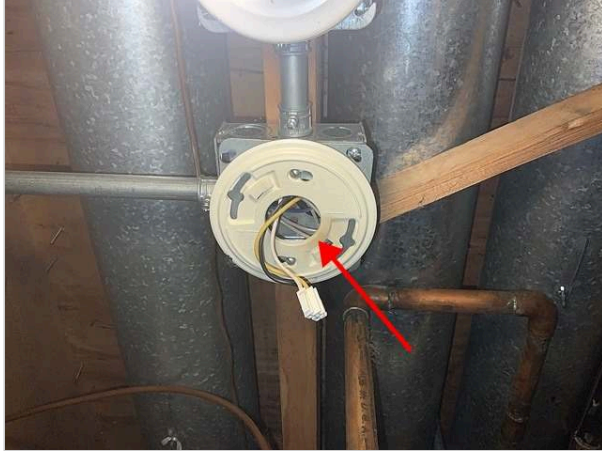
4. Structure - Smoke Detector(s)

There was a missing smoke detector in the utility room at the time of the inspection. We recommend replacement of the smoke detector, and ensuring that the smoke detector is connected to the wired system, prior to occupying the structure.

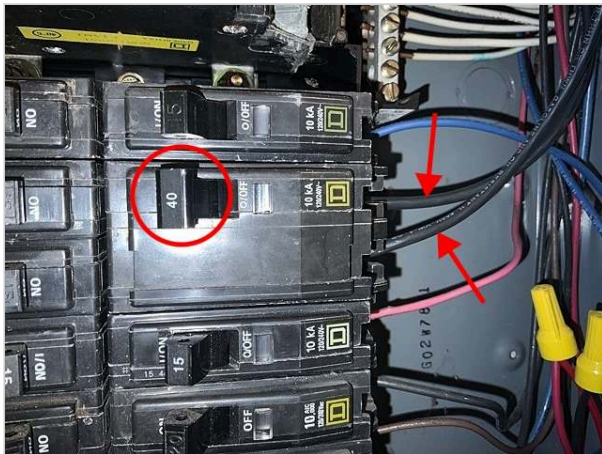
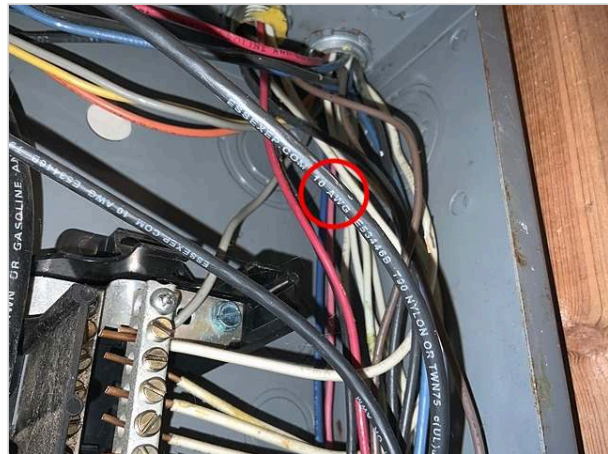
5. Electrical Service - Wire-Over Current Compatibility Maintenance

There appears to be # 10 copper wires leading to a 40 amp breaker in the electrical panel. Typically, this is an under-sized wire for this size of breaker. We recommend contacting a qualified electrician for further evaluation and repairs as needed.

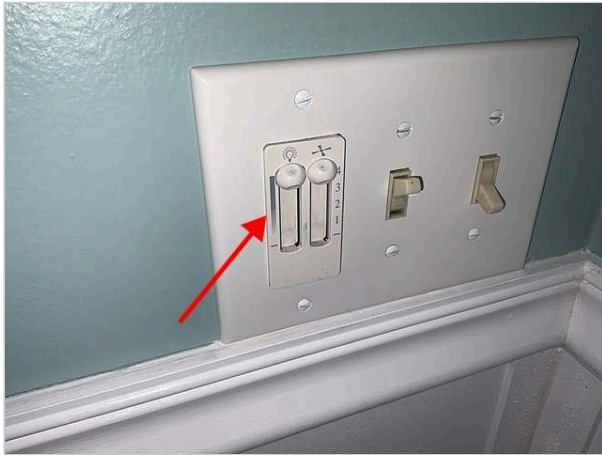
6. Electrical Service - Outlets, Switches, Junction Boxes, Lighting Attention

The dimmer switch for the living room ceiling fan made a "buzzing" sound and the dimmer did not appear to be functional. We recommend contacting a qualified electrician for further evaluation and recommendations for repair.

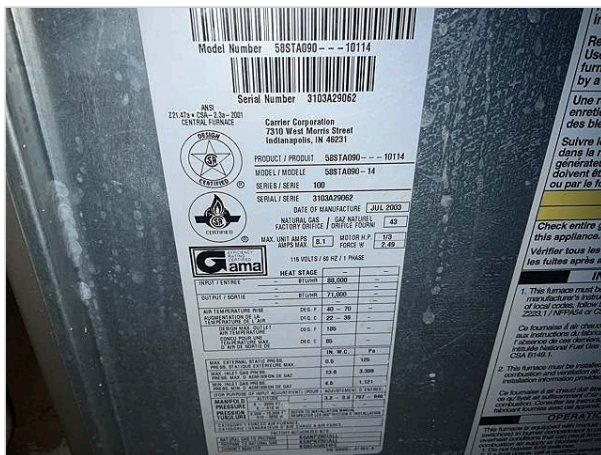
Furnace - 2003

The heating and air conditioning units appeared to be functional at the time of the inspection, however, the units are older and may be approaching the end of their serviceable life. The typical life expectancy of an air conditioning unit is 12-15 years and 15-20 years for a heating unit. We recommend questioning the seller regarding the last time the units were evaluated and serviced, and budgeting for replacement at this time. It is recommended that a qualified HVAC company is contacted for further evaluation and estimates.

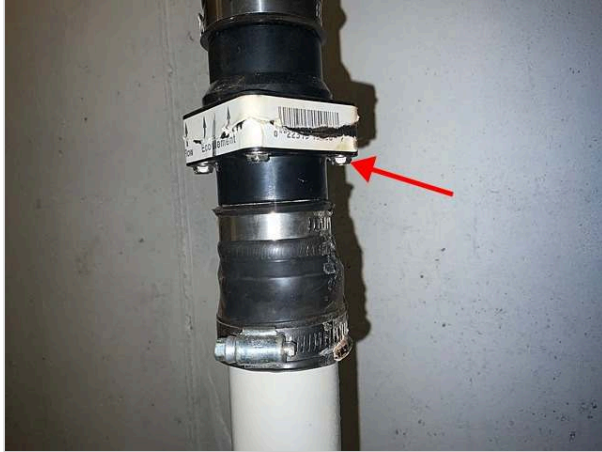
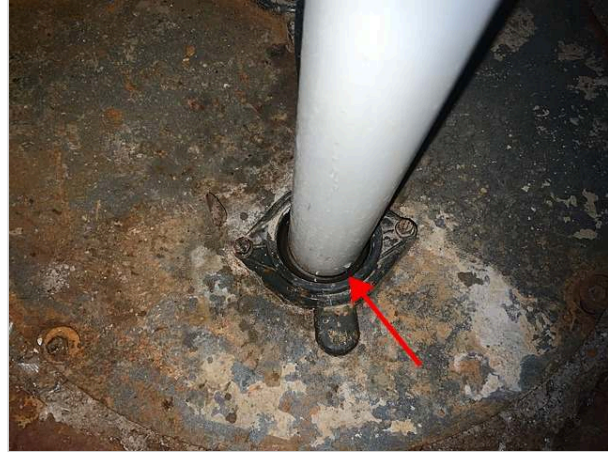
The inspector noted a leak from the check valve for the waste ejector. It is recommended that a qualified handy person or plumber is contacted for evaluation and repair prior to larger leaks developing.

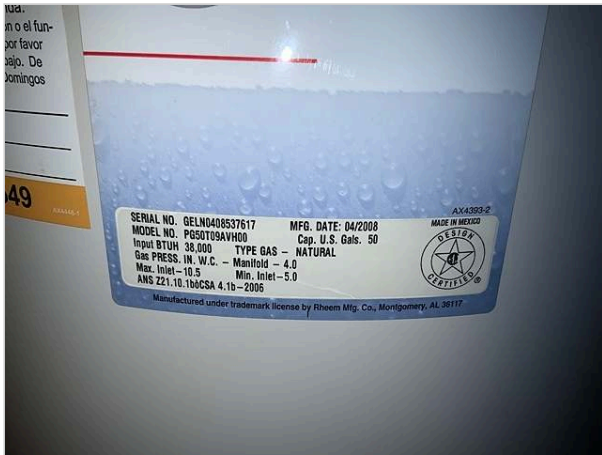
Water Heater - 2008

There were no service records mounted on the water heater. The water heater is approximately 13-15 years old, and may be approaching the end of its service life. A water heaters service life is approximately 8-12 years from the date of installation. The unit appeared to be functional at the time of the inspection; however, due to the age of the water heater, we recommend budgeting for replacement at this time.

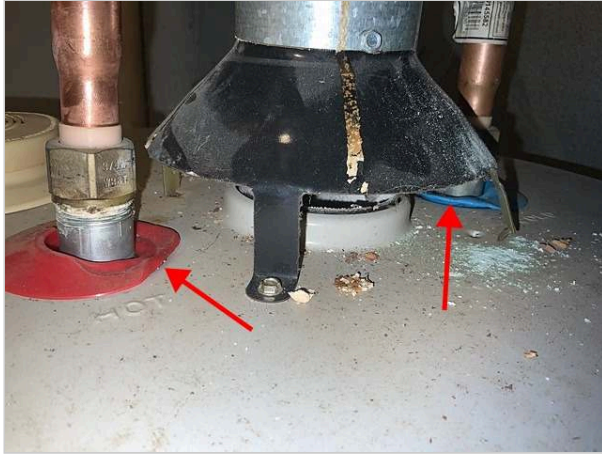
11. Water Heater - Installation

The inspector noted that the plastic rings around the water connections at the top of the water heater tank have melted. This issue typically indicates that the water heater is back-drafting. The inspector recommends having this issue evaluated by a qualified HVAC company to ensure safe functional use.

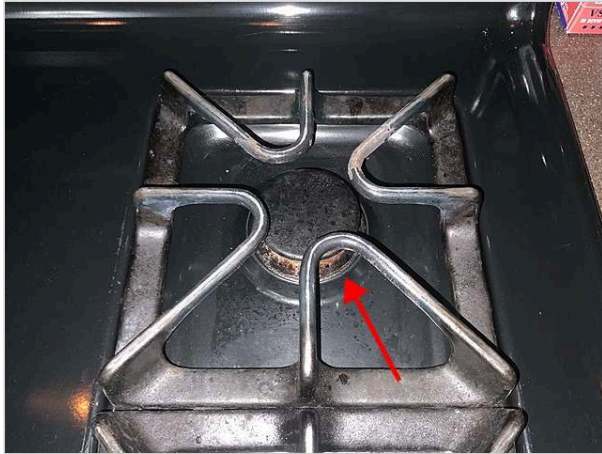
12. Kitchen(s) - Cook top, Burners/Elements

The back right burner did not ignite at the time of the inspection. The burner may need maintenance in order to operate properly. We recommend questioning the seller regarding their knowledge of this issue, and contacting an appropriate trade or appliance repair company for evaluation/repairs.

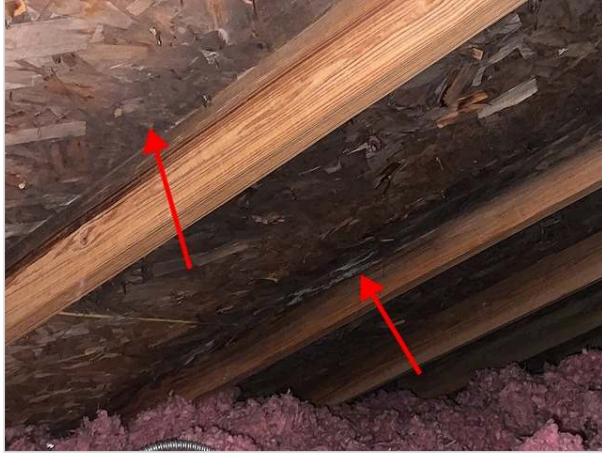
There are areas of the attic which display possible microbial growth, such as on the roof sheathing/framing. Further investigations are recommended to determine the cause and remedy. We recommend contacting a qualified mold inspection company for testing and examination.

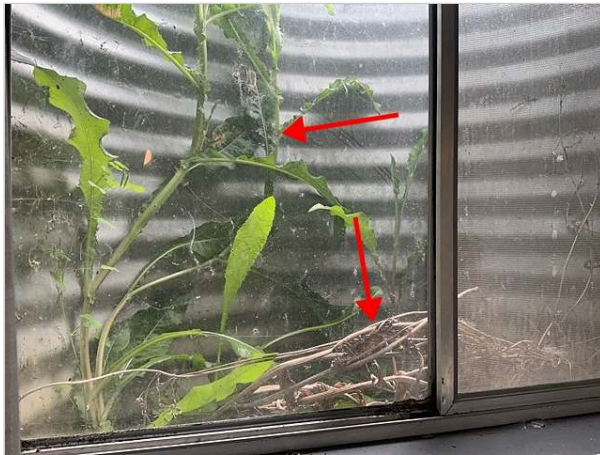
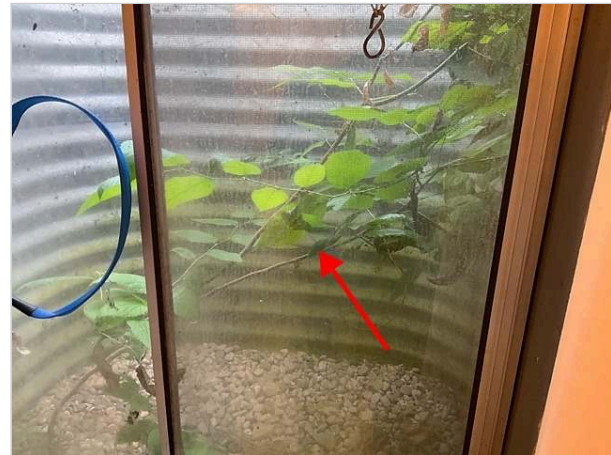
There was no escape ladder installed in the egress window well at the time of the inspection. We recommend installing an escape ladder in order for someone to exit the basement in case of emergency. Escape ladders can be purchased from many home improvement stores.

The inspector noted a considerable amount of vegetation in the window wells at the time of the inspection. All debris should be removed on a regular basis as a preventative measure.

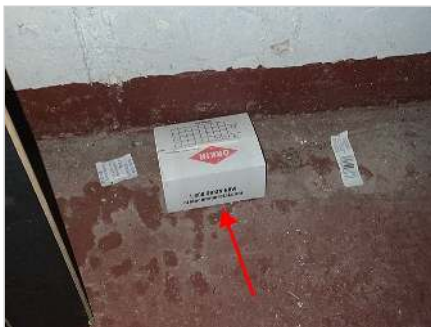
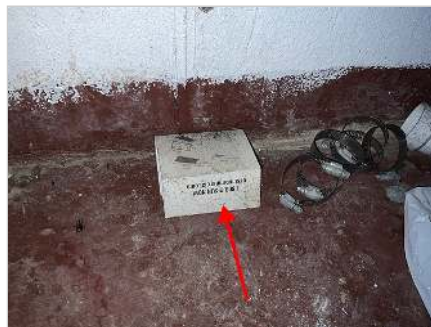
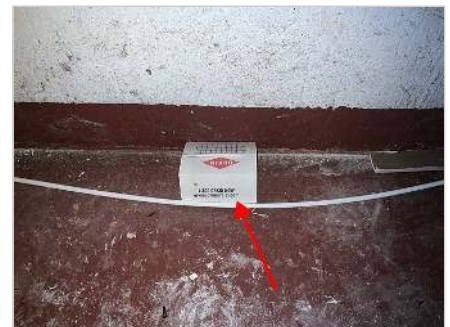
14. Evidence of Insects

The inspector noted traps in the basement. We recommend questioning the seller regarding their knowledge of this issue and contacting a qualified pest control company for further evaluation and control measures.

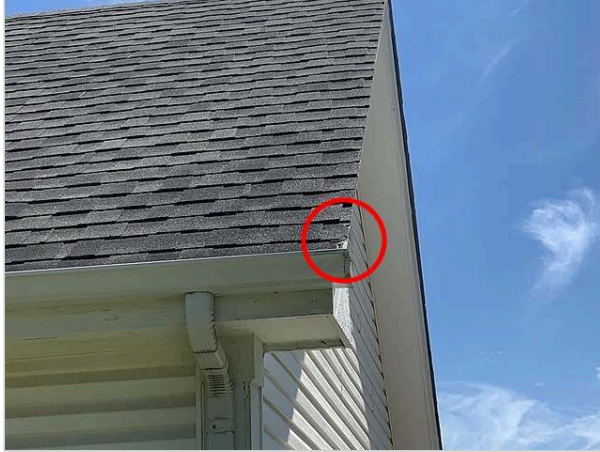
The roof cover appears to be 7-12 years old and showing general wear. There was granulation loss throughout the surface and a damaged shingle noted at the front left corner of the home. This type of material typically has a life expectancy of 20-30 years from the date of installation. We recommend questioning the seller regarding the actual age of the roof cover.

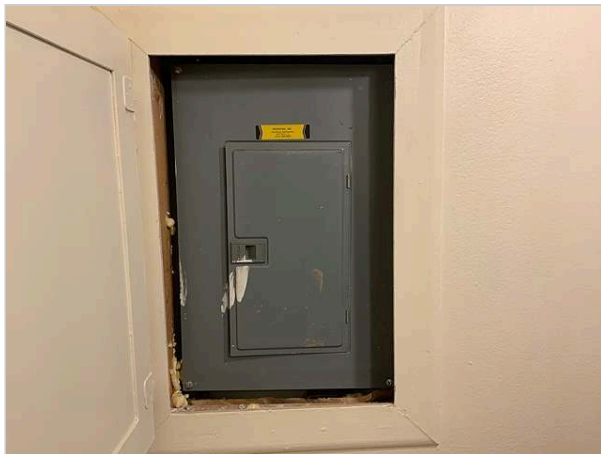
Note: By today's standards there was a lack of clearance to access the electrical panel. Consideration may need to be given to contacting a qualified electrician to make recommendations as a preventative measure.

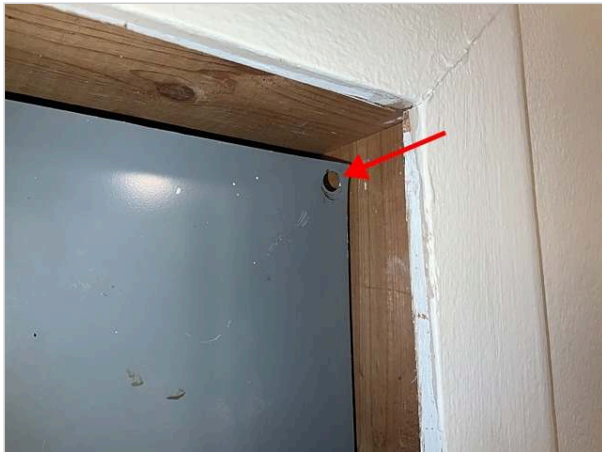
There is a screw missing to secure the dead-front panel on the electrical panel. Installing a proper screw to prevent unwanted access and properly secure the panel is recommended.

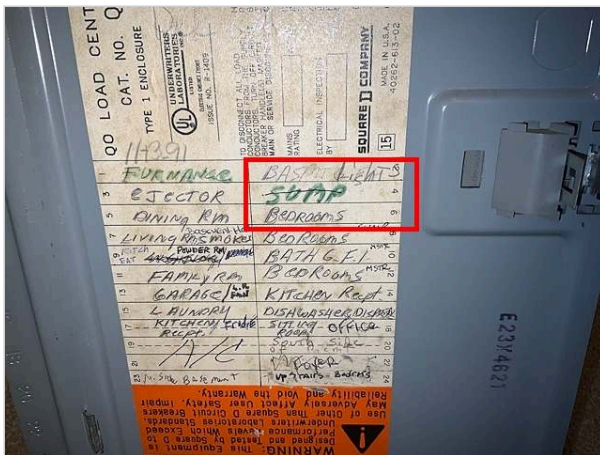
The breakers are not fully labeled for use at the electrical panel. We recommend the panel be appropriately labeled to show the circuits supplied by each breaker.

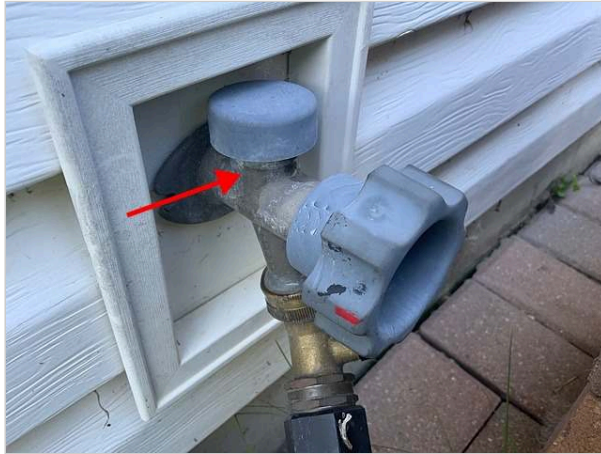
The exterior spigot at the back of the home appeared to be leaking from the top of the spigot at the time of the inspection. The inspector recommends contacting a qualified handy person or plumber for repairs or replacement for functional use.

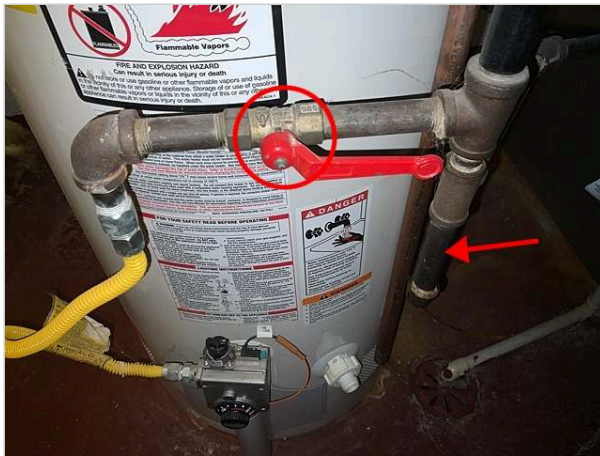
The water heater has a "Sediment Trap" incorrectly installed prior to the shut-off valve. Sediment traps are installed in the natural gas service lines to catch and protect systems from debris and/or moisture. A sediment trap shall be installed downstream of the appliance shut off valve, as close to the inlet of the appliance as practical at the time of appliance installation. This issue does not present a safety hazard; however, consideration should be given to having this issue evaluated when the system is upgraded/replaced.

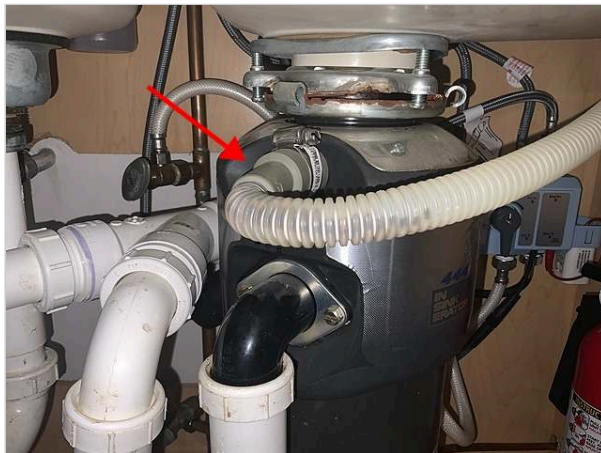
The dishwasher drain hose has been connected to the garbage disposal. This is a nonstandard configuration in many jurisdictions. We recommend contacting a qualified plumber for further recommendations.

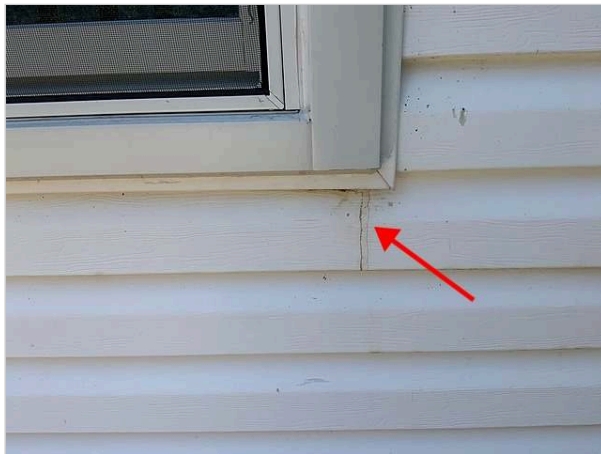
The inspector noted moisture stains below the living room windows at the exterior of the home. We recommend monitoring these areas in order to determine if further action is needed. It is recommended that a qualified window company is contacted for evaluation and repairs as needed.

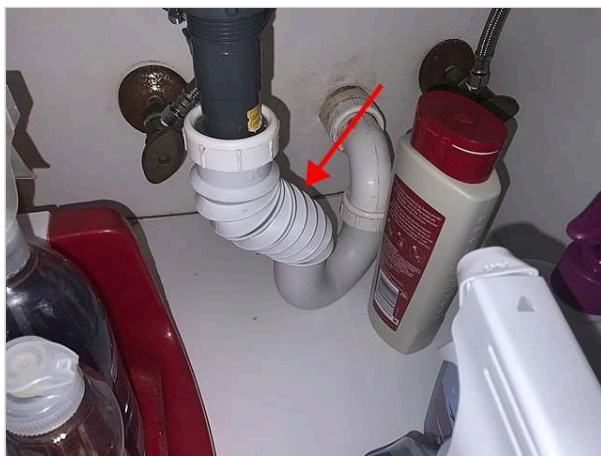
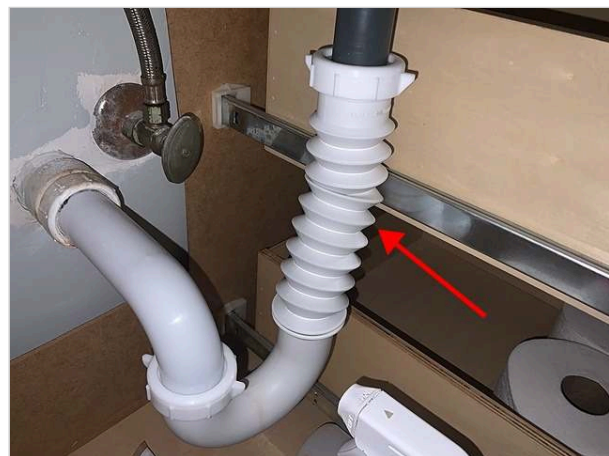
The hallway bathroom and 1/2 bathroom sink drains have been configured with flexible plumbing. The drains appeared to be functional; however, this type of material does not meet the standard of the plumbing trade. We recommend contacting a qualified plumber for recommendations.

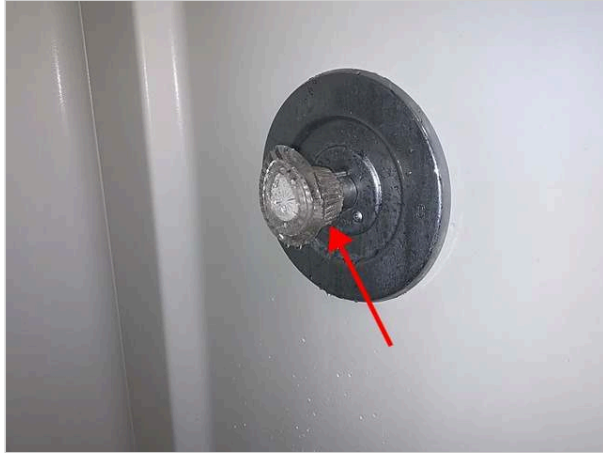
The hot and cold water were reversed at the master bathroom shower. It is recommended that a qualified handy person or plumber is contacted for repairs in order to prevent accidental scalding.

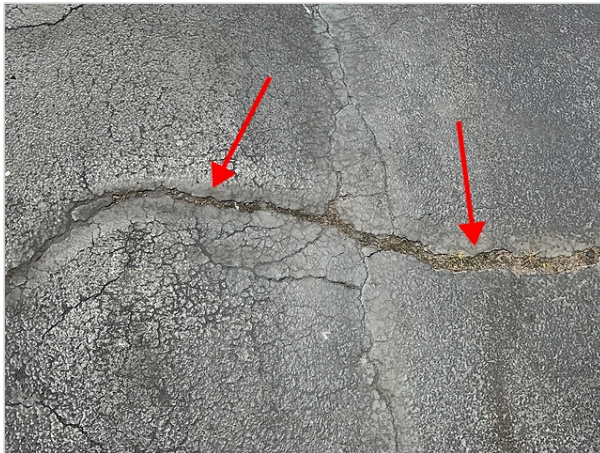
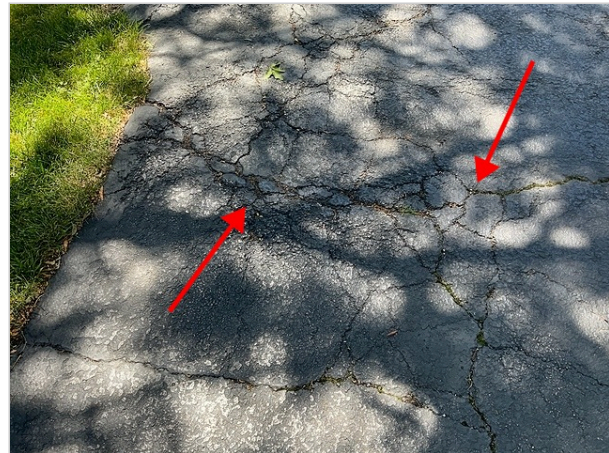
The asphalt driveway has several cracks in the surface material and is showing wear. It is advisable to restore or patch the surface before progressive deterioration takes place. We recommend contacting a qualified driveway repair company for estimates.

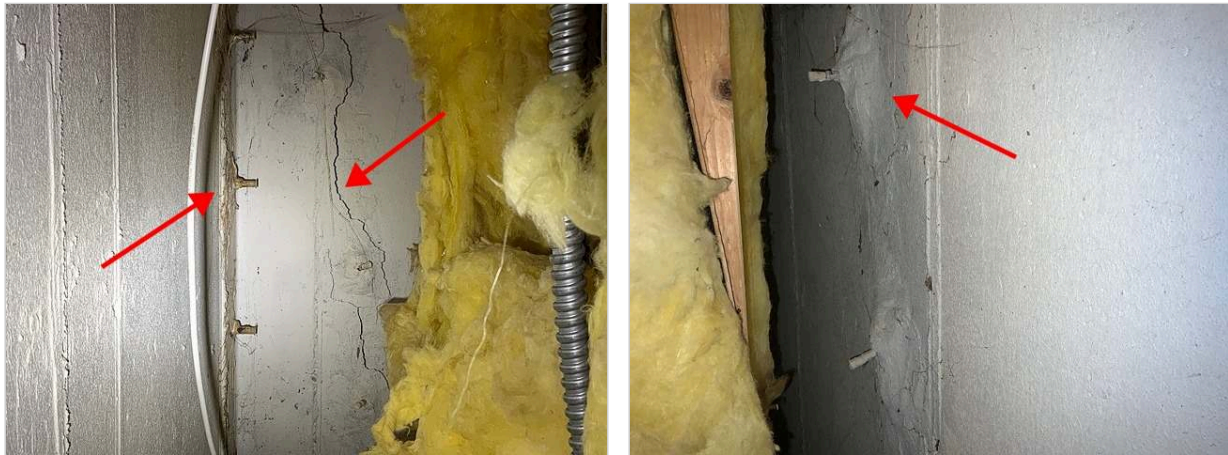
The inspector noted several repairs made to the basement foundation. Also, there was a repair that appears to have cracked again. We recommend questioning the seller regarding any moisture penetration in the basement during their ownership as well as any warranty information for the repairs made. It is recommended that these areas are monitored in order to determine if further action is needed.

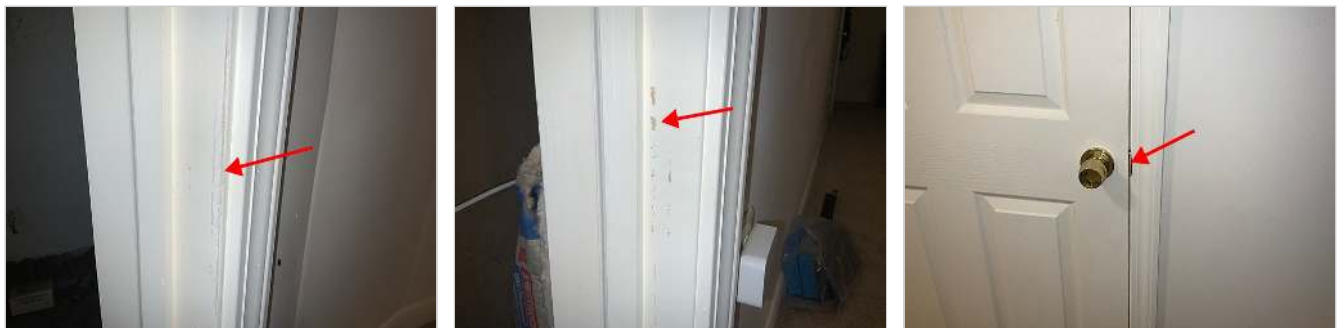
There were doors throughout the basement that did not latch or were rubbing in areas along the door frame. We recommend adjustments or repairs for functional use.
