Prepared For: ABCDEF

Property Address: 123 Main Street

Inspector: WIN Home Inspection
Company: WIN Home Inspection
www.wini.com

Standard Full Home Inspection

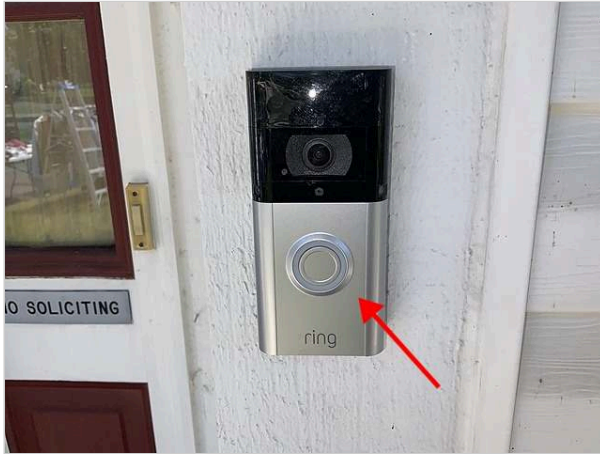
Ring Doorbell - Not Tested

There was a Ring doorbell installed at the time of the inspection. We recommend questioning the seller regarding the functionality and/or any transferable subscriptions.

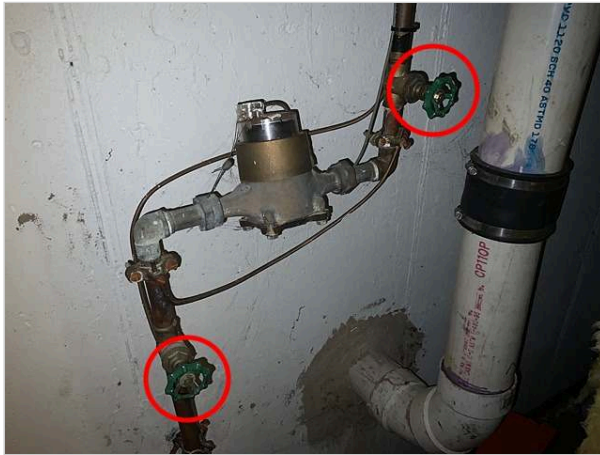
At Meter

We recommend you ask the current owner if another main shut-off valve exists at the property, besides at the meter.

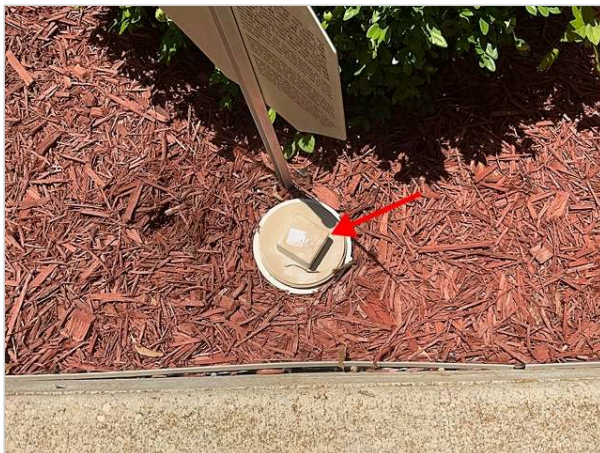
Exterior

A clean-out was located at the front of the home. Sewer clean-outs with back-flow protection are required in some areas, and needed to allow a plumber to access the main sewer line in case of back-ups or blockages.

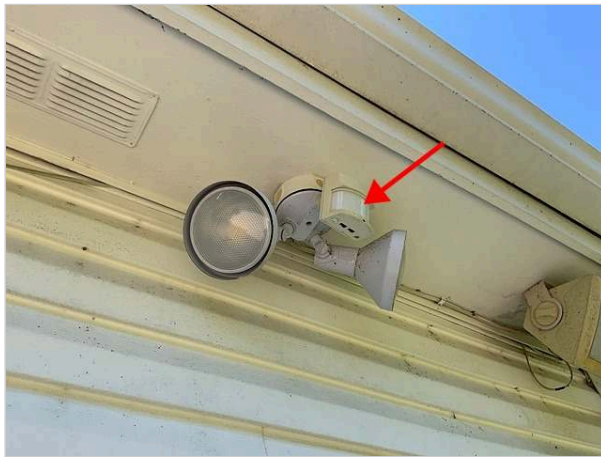
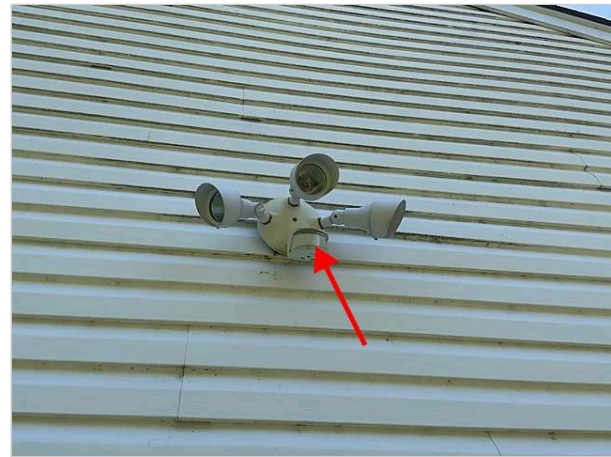
There were exterior light fixtures that appeared to be on a motion/light sensor. We recommend questioning the seller regarding the operation and condition of the fixtures.

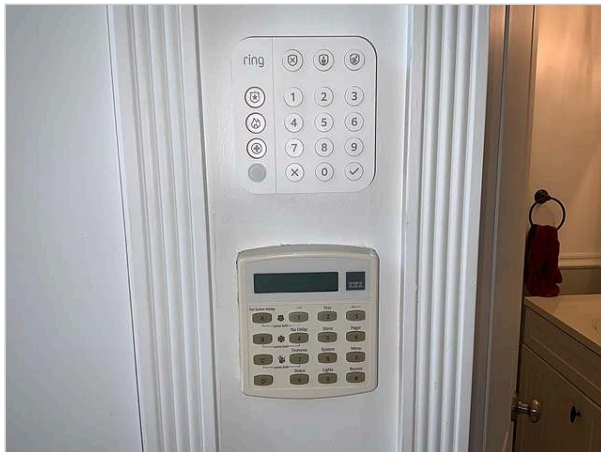
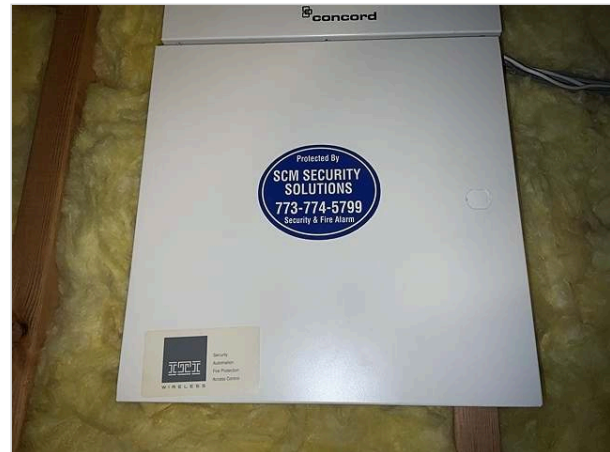
The structure appeared to be equipped with a security system which should provide for added safety. The system was not tested/inspected under the scope of this inspection. The inspector recommends questioning the current home owner if the system is operational, and on how to operate the system.

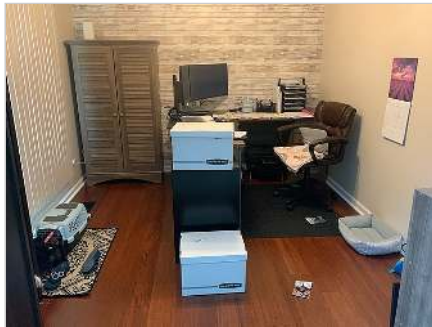
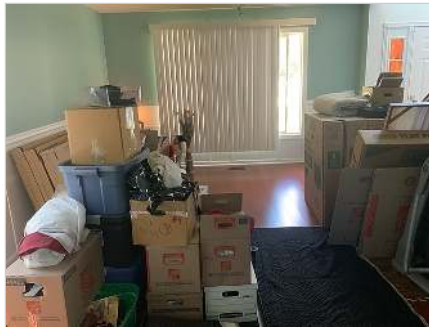
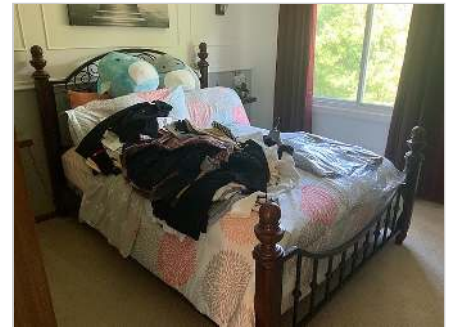
The inspector feels the amount of furniture and/or stored items in the home significantly limited the ability to visually inspect various and or certain items. The inspector recommends the home be re-inspected when vacated.

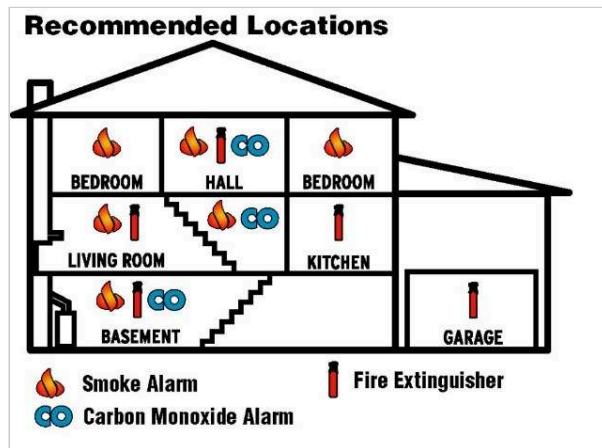
We recommend installing fire extinguishers in kitchens, laundry areas, basements, and garages, as well as one per level of the home. Extinguishers would be a potential life saving device and aid in the reduction of a fire spread. Also, a ladder escape system is recommended for any upper story living area in order to escape in case of a fire. Extinguishers and ladder escape systems can be purchased at any home repair center or hardware store and would be a potential life saving device.

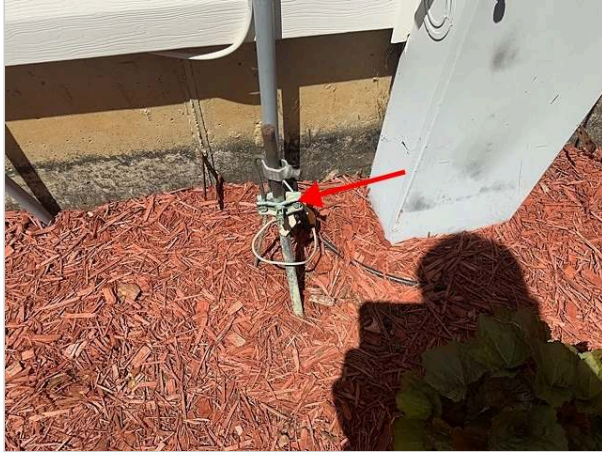
The main ground to the service has been verified near the electrical meter.

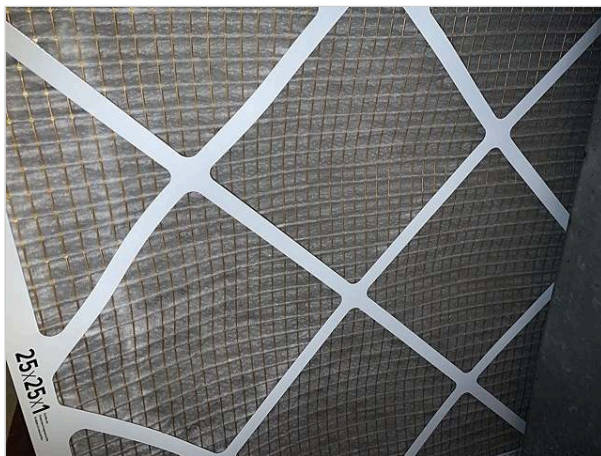
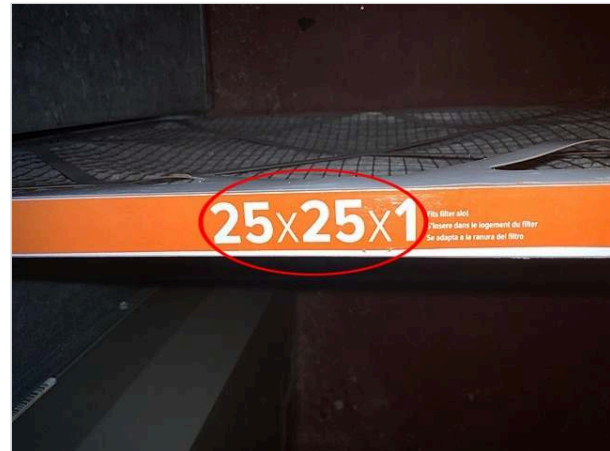
There was debris on the furnace filter at the time of the inspection. We recommend replacing the filter at this time.

Note: The inspector recommends the filter be cleaned/replaced on a periodic basis as needed.

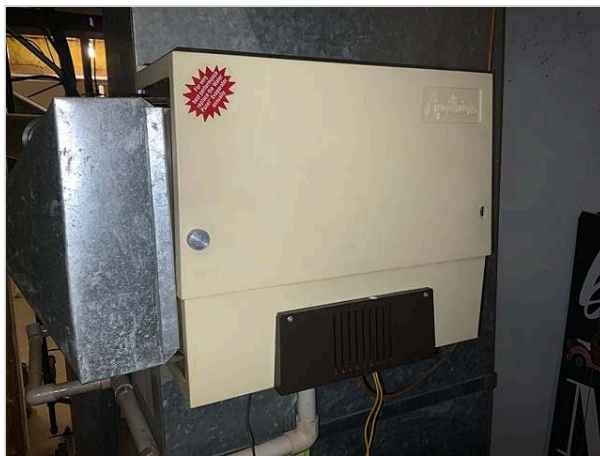
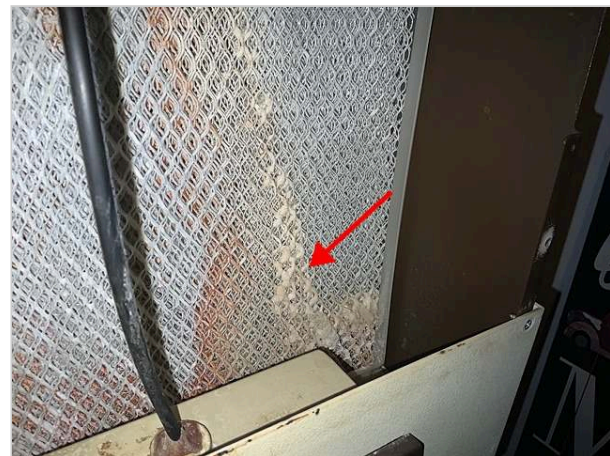
The humidifier was operated while testing the furnace performance. The unit responded to its humidistat with water flowing thru the media pad. Replacement of the pad is recommended at the beginning of each heating season. The inspector recommends having the unit evaluated and the filter(s) cleaned/replaced when the HVAC systems are evaluated and serviced.

Note: There was heavy debris on the humidifier filter. We recommend having the filter replaced at this time. Contact a qualified HVAC company for repairs as needed.

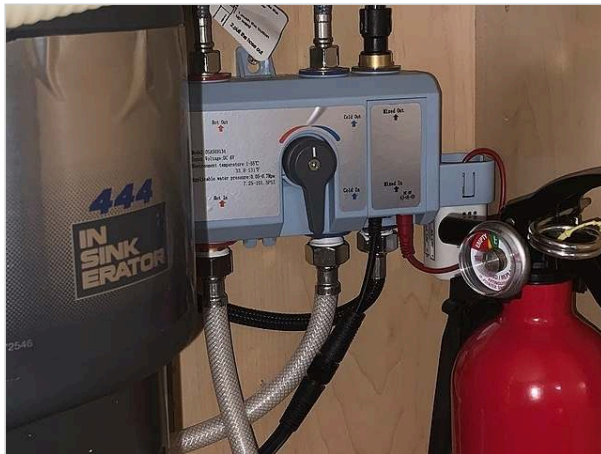
There appears to be an active water filtering system at the kitchen sink; however, this inspection does not cover the adequacy or extent of the system. We recommend you ask the owner about the condition and maintenance on this item. Replacement of filters and cartridges is important maintenance with these type of systems.

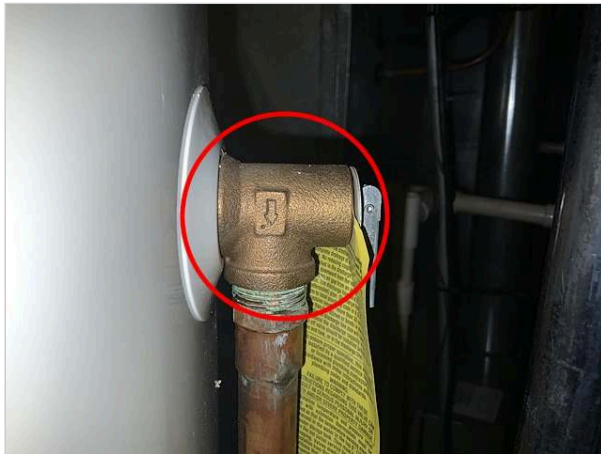
Visual Check - Not Tested

There is a safety valve (TPR valve) on the water heater tank; however, it could not be tested because once it has been opened, the valves tend to leak.

Note: Safety relief valves should be re-inspected **at least once every three years** by a licensed plumbing contractor or authorized trade, to ensure the product has not been affected by corrosive water conditions and to ensure that the valve and discharge line have not been altered or tampered with illegally. Certain naturally occurring conditions may corrode the valve or its components over time, rendering the valve inoperative. Such conditions are not detectable unless the valve and its components are physically removed and inspected. This inspection must only be conducted by a plumbing contractor or authorized trade - not by the owner. Failure to re-inspect the relief valve as directed could result in unsafe pressure buildup, which can result in severe personal injury, substantial property damage, etc.

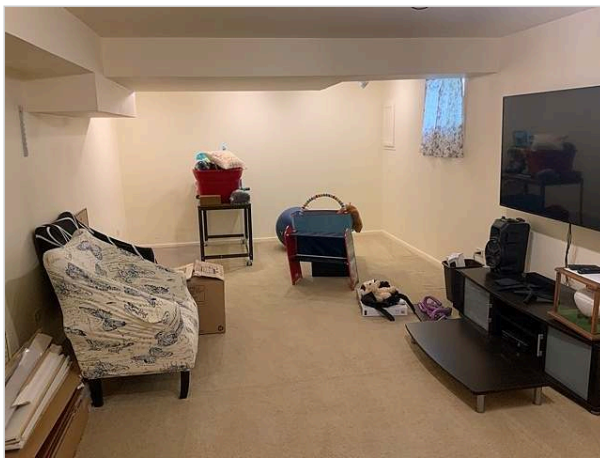
The basement has been finished. The inspector had limited view of the foundation floor and walls. Issues may exist that were not visible at the time of the inspection. It is recommended that the seller is questioned regarding any leaks in the foundation during their ownership.
